Watershed Management Plan for New Brooklyn Lake

April 2004

Camden County, New Jersey

Urban Engineers, Inc. and 530 Walnut Street Philadelphia, PA 19106

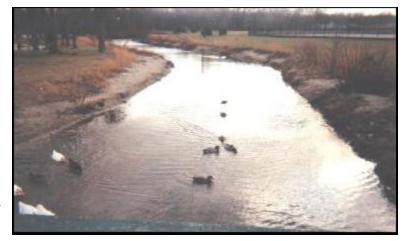
Excessive numbers of waterfowl were noted on the Great Egg Harbor River at Berlin Park. Nuisance waterfowl can create major water quality problems for lakes and streams. The large numbers of waterfowl, mainly Canada geese and gulls, aggravate shoreline erosion problems by walking up and down the banks. The waterfowl droppings are also a problem and are a direct source of phosphorus, nitrogen, and bacteria to the stream and lake.

Nuisance waterfowl, inadequate riparian buffer, and eroded shorelines along the Great Egg Harbor River in Berlin Park

One of the most critical management practices to improve the New Brooklyn watershed is the stabilization of streambanks and shorelines. In particular, areas of erosion were observed on the Great Egg Harbor River where it flows through Berlin Park and along Cedar Brook Road near New Brooklyn Lake. Additionally, it is likely that other areas of streambank erosion exist along tributaries on private land that could not be inspected as part of this project. Soil erosion along streambanks is a major source of nonpoint pollution in watersheds. Certain nutrients as well as many other pollutants adhere to eroded soil particles and are introduced to the waterways. Lakes and reservoirs are particularly affected by nutrients associated with sediment loads. These large, still bodies of water serve as settling basins for the particulate matter that is transported by their contributory streams.

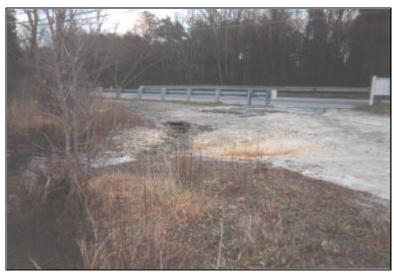
Road Runoff causing erosion and entering New Brooklyn Lake untreated

Concrete channels within the watershed should be retrofitted with grassed swales or directed to stormwater practices that are designed to reduce peak flow velocities and infiltrate stormwater rather than allowing it to enter the stream directly. Concrete channels provide no stormwater treatment, and often allow stormwater to flow at high speeds, causing erosion at the stream outfall.

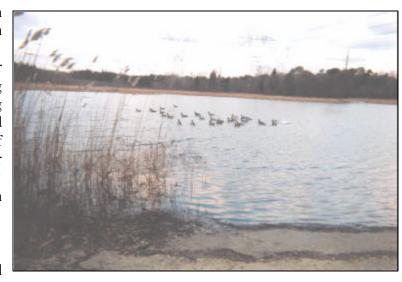
Canada Geese at New Brooklyn Lake

levels in downstream waterbodies. These problems have a negative impact on the ecological balance of the water body, and can threaten other native species. Excessive numbers of waterfowl were observed at Berlin Park during the watershed investigations.
